Application Number : B28/2017/0062	Date Valid : 23/01/2017
Address : 2 Abbey Way, Barrow-in-Furness, Cumbria, LA14 1BP	Case Officer : Charles Wilton
Proposal : Application to fell T3* (Horse Chestnut) and T4 (Yew) subject of Tree Preservation Order 1998 no 4. * Made subject of a 5 day fell notice	
Ward : Hawcoat Ward	Parish : N/A
Applicant : Mr Daniel Greaves, 2 Abbey Way, Barrow-in-Furness.	Agent : Mr B Greaves, Greaves Tree Services, Dalton Road, Askam-In-Furness.
Statutory Date : 20/03/2017	Recommendation :

2 ABBEY WAY – APPLICATION TO FELL HORSE CHESTNUT (T3 IN TPO 4, 1998)

2 ABBEY WAY – APPLICATION TO FELL A YEW TREE (T4 IN TPO 4, 1998)

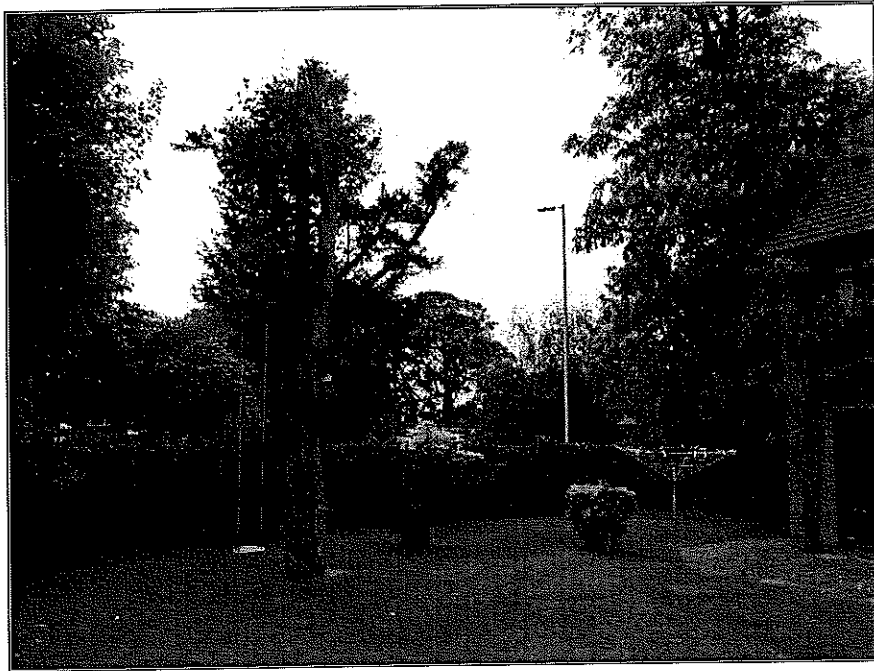
Photograph 1
T4 from inside the garden of 2 Abbey Way.

- There is dead bark and exposed sapwood around much of the trunk with some decay.
- There are a lot of dead branch stubs on this tree.
- There are two smaller stems growing from the trunk at 1m and 1.2m respectively. These are alive.

I consider that this tree more than likely suffered a trauma, probably when the site was developed and the nearby underground services were installed.

The tree that is the subject of this letter has suffered a trauma and is in poor condition. It is not dangerous but I suggest that it is not visually attractive. It can be seen from Abbey Road but there are larger trees in the vicinity. This tree will not grow to become a fine large specimen. I suggest that a replacement tree would soon grow to make a similar or greater visual contribution to the area and would ensure that trees remain part of the landscape for decades to come.

The tree is not visually attractive. I therefore recommend that permission should be granted to fell it on the condition that another tree is planted as a replacement. This will grow to become a landscape feature and ensure that trees contribute to the visual character of the area for decades to come. I recommend that the replacement tree should be a type that will grow relatively tall but not very wide to allow light to the building. Suitable species include Cypress oak (*Quercus robur* 'Fastigiata'), Dawyck Beech (*Fagus sylvatica* 'Dawyck'), and Lawson Cypress Wisselii (*Chamaecyparis lawsoniana* 'Wisselii'). I will happily provide advice about other species that may be considered as replacements for T4.

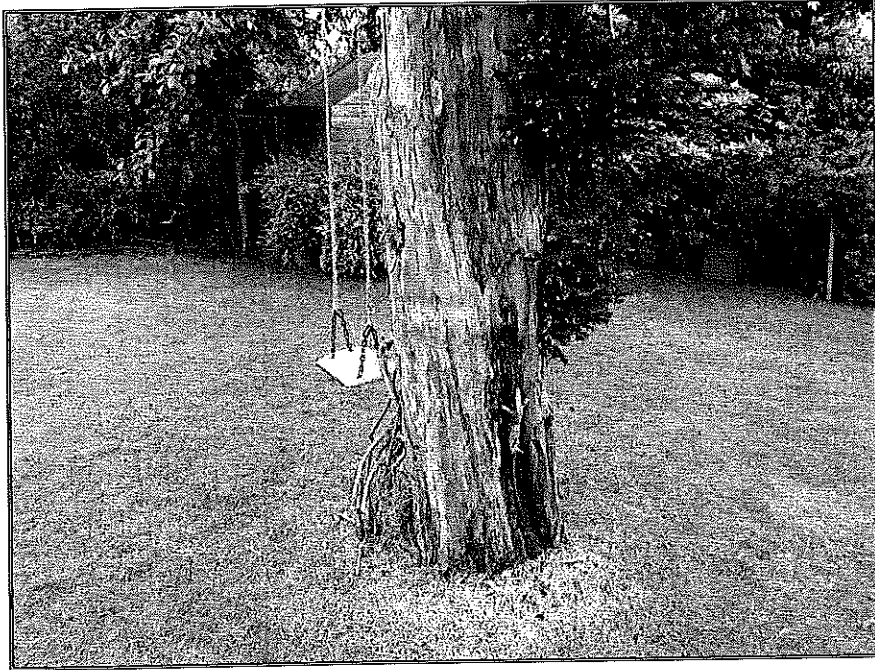
Photograph 3

The base of the trunk of T4 showing the extensive area of exposed sapwood and dead bark.

The reduction in foliage on the tree due to the trauma and resulting crown dieback created a situation where there was less carbohydrate available for maintenance respiration and consequently some of the bark on its trunk died.
